**SUPPLEMENTAL TYPE CERTIFICATE NUMBER SA11103SC  
INSTALLATION OF SAFETY SYSTEMS FOR  
BEECHCRAFT B200GT AND B200CGT AIRPLANES  
IN THE KING AIR 250 CONFIGURATION  
(PRO LINE 21 AND PRO LINE FUSION AVIONICS)**

**FAA APPROVED  
AIRPLANE FLIGHT MANUAL SUPPLEMENT**

AIRPLANE FLIGHT MANUAL SUPPLEMENT  
FOR KING AIR 250 AIRPLANES WITH  
CENTEX AEROSPACE SAFETY SYSTEMS CONVERSION

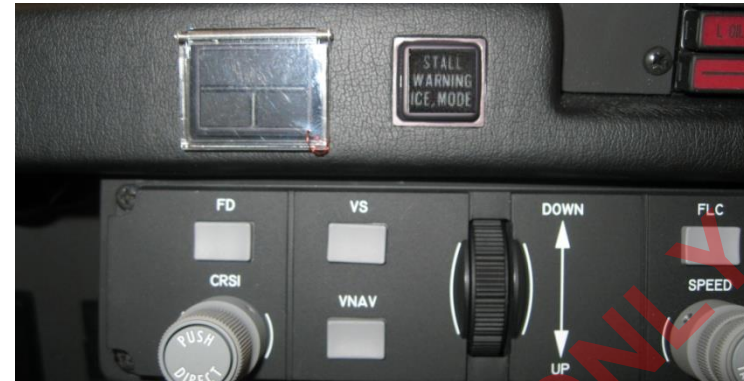
FIGURE 7-2  
STALL WARNING ICE MODE ANNUNCIATOR

Switching to the ice mode occurs automatically when the pilot selects either SINGLE or MANUAL on the Surface Deice switch. The STALL WARNING ICE MODE annunciator, which is located in the glareshield in front of the pilot, will illuminate whenever the ice mode is active (See FIGURE 7-2). The ice mode will stay active until it is manually deactivated by the pilot pressing the illuminated annunciator. This should be done when the airplane is outside of icing conditions and is free of ice. Pressing the annunciator when it is extinguished has no effect. Note the stall warning heat must be operating when flying in icing conditions to keep the lift transducer free of ice.

An ICE MODE feature has been added to the stall warning system. The ice mode is automatically activated when the Surface Deice system is selected by the pilot. Illumination of the STALL WARNING ICE MODE annunciator indicates the stall warning system is operating in the ice mode. After exiting icing conditions and when the aircraft is free of ice, transfer the stall warning system to the normal mode by pressing and releasing the STALL WARNING ICE MODE annunciator.

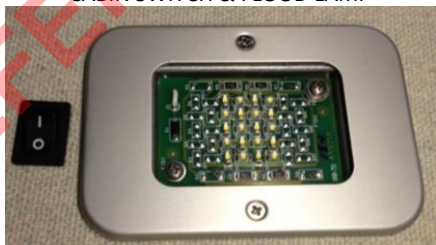
FIGURE 7-3  
EMERGENCY CABIN LIGHTING SYSTEM  
CABIN SWITCH & FLOOD LAMP

The Safety Systems conversion adds a cabin emergency lighting system. It provides supplemental lighting in the cabin around the emergency exit door and cabin door. The system has two LED flood lamps located in the cabin ceiling that are powered by a dedicated battery pack, which contains two 12-volt, sealed lead-acid batteries connected in series, installed under the cabin floor.

Two switches operate the system and provide required functionality. A cabin switch located next to the aft flood lamp connects the battery pack to the system (See FIGURE 7-3). A control switch located in the pilot's sub-panel arms automatic operation or provides manual operation of the flood lamps from the cockpit (See FIGURE 7-4). Power to charge the battery pack is fed from the main electrical bus through a five (5) amp circuit breaker labeled EMERG LIGHT in the copilot circuit breaker panel (See FIGURE 7-5 thru FIGURE 7-8).

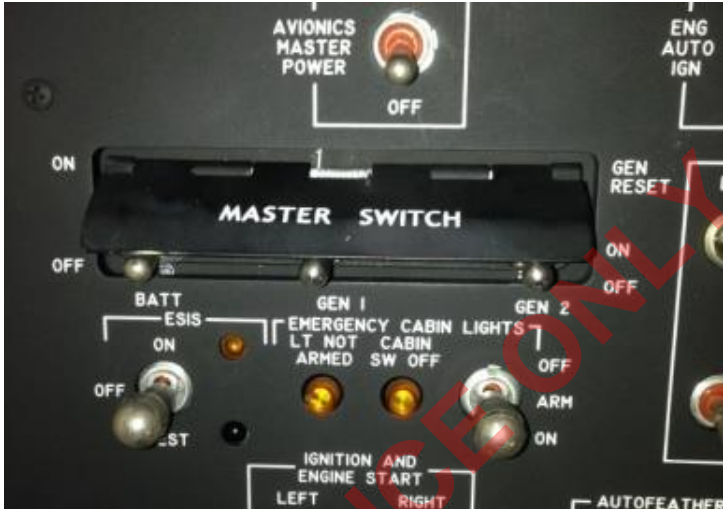
FIGURE 7-4  
EMERGENCY CABIN LIGHTING SYSTEM  
COCKPIT CONTROL SWITCH and WARNING LIGHTS

Two amber indicator lights located adjacent to the control switch (See FIGURE 7-4) warn the pilot when the system switches are not set as required for taxi and takeoff operations. The amber indicator lights will be extinguished when the cockpit control switch is ARMED and the cabin switch is ON. Note these are the required positions for taxi and flight operations.

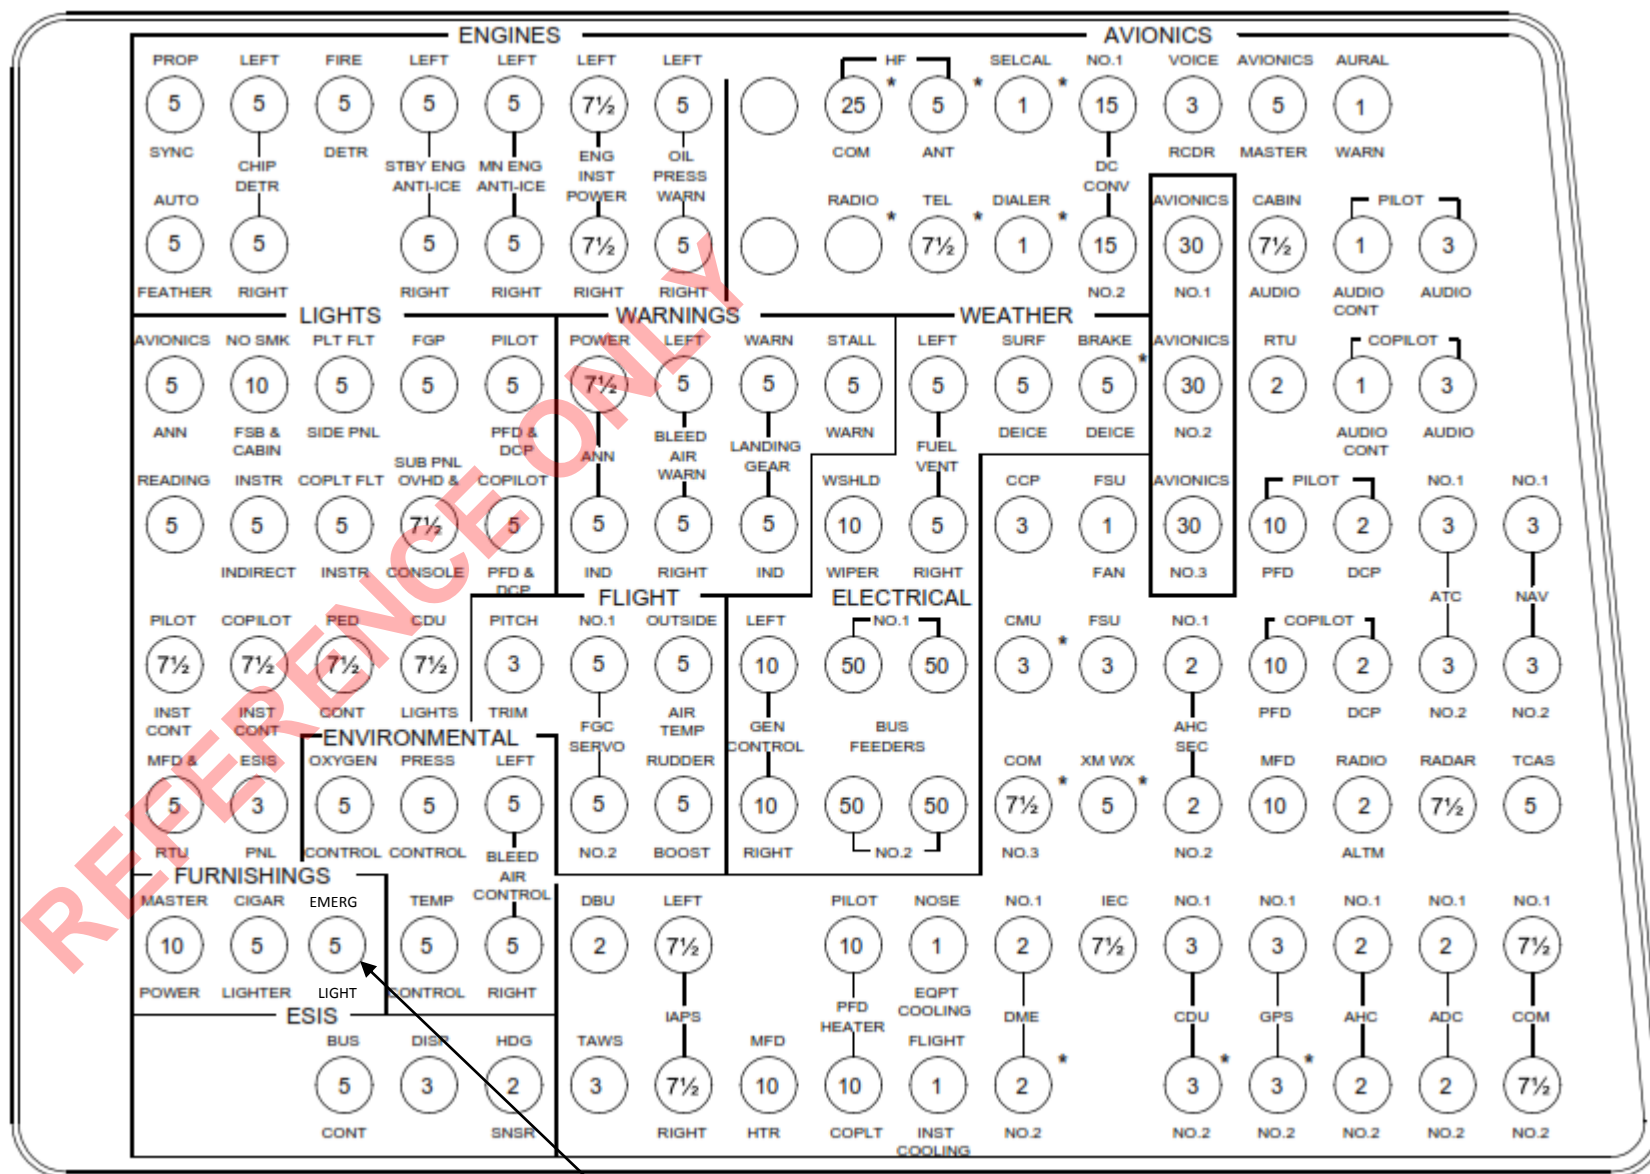
FIGURE 7-5  
RIGHT CIRCUIT BREAKER PANEL (PRO LINE 21)

EMERGENCY LIGHTING SYSTEM CIRCUIT BREAKER

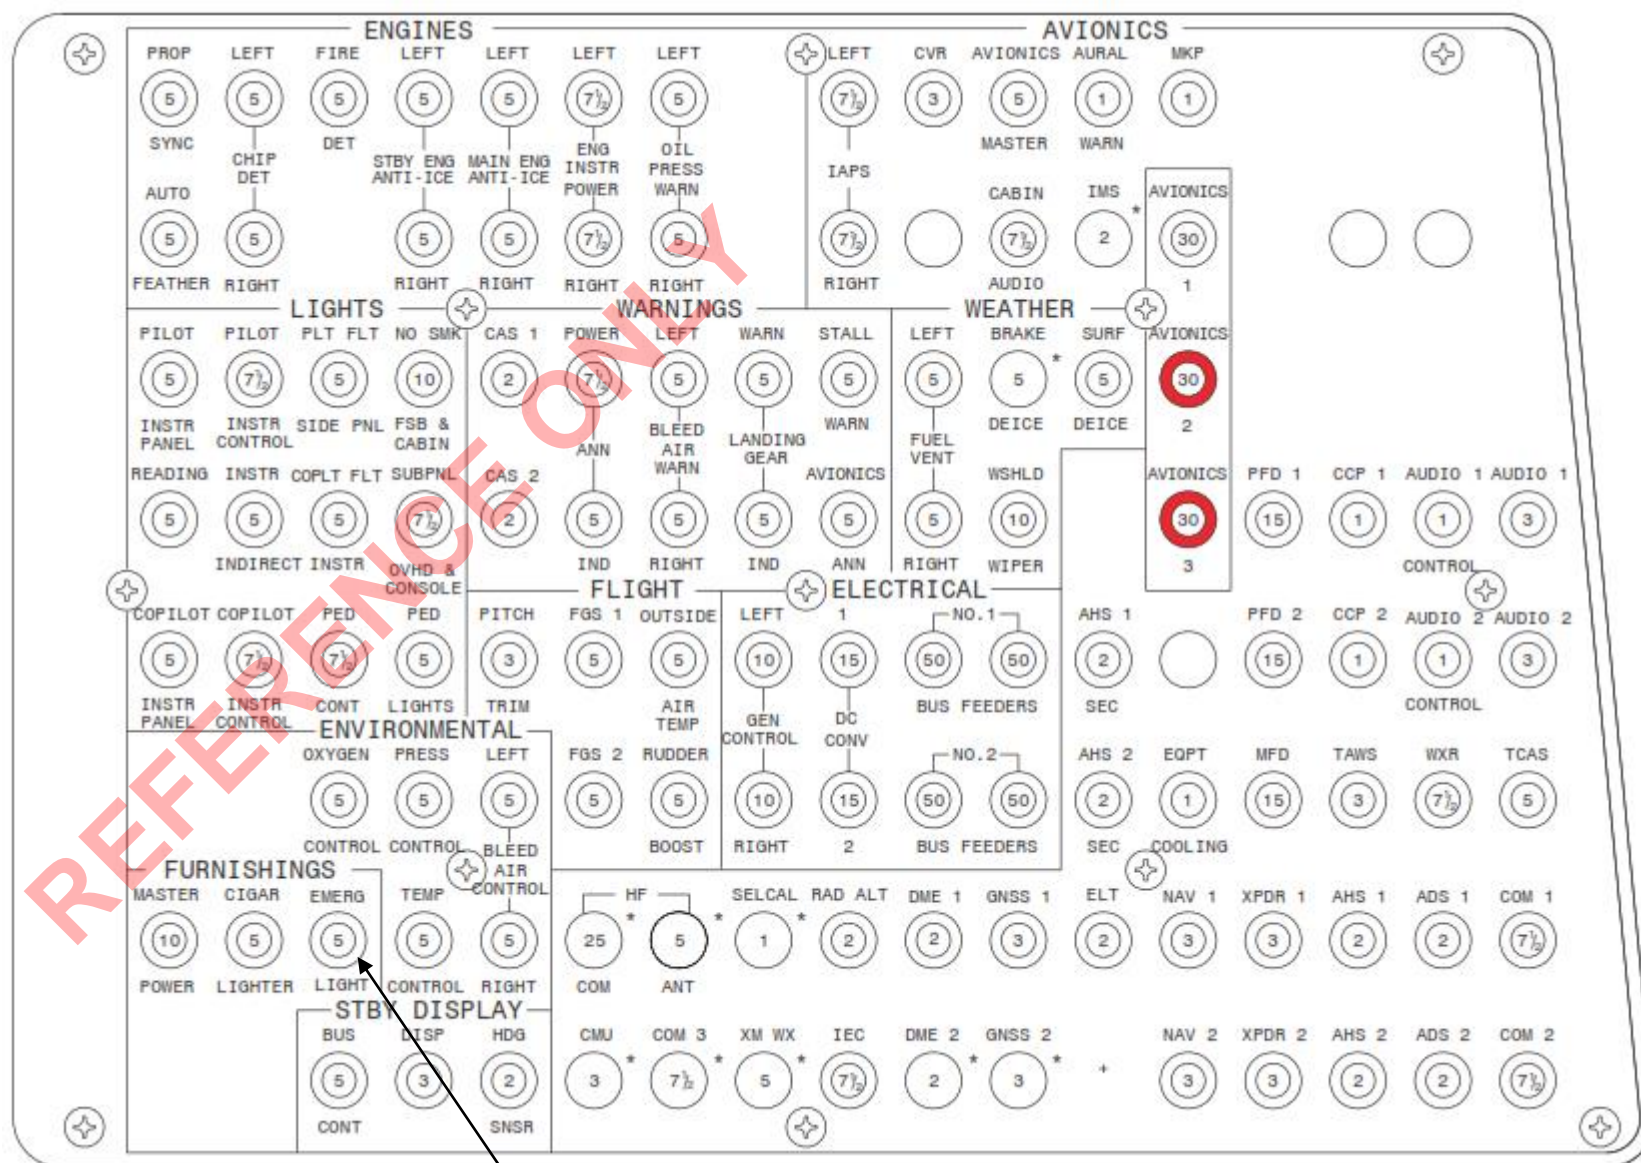
FIGURE 7-7  
RIGHT CIRCUIT BREAKER PANEL (PRO LINE FUSION)

NOTE: SOLID RED COLOR BAND AROUND CB IS FOR LOAD SHEDDING.
