**SUPPLEMENTAL TYPE CERTIFICATE NUMBER SA11103SC  
INCREASED MAXIMUM ZERO FUEL WEIGHT LIMIT AND  
INSTALLATION OF SAFETY SYSTEMS FOR  
BEECHCRAFT B200GT AND B200CGT AIRPLANES  
IN THE KING AIR 250 CONFIGURATION**

**FAA APPROVED  
AIRPLANE FLIGHT MANUAL SUPPLEMENT**

HALO 250/275 CONVERSION OPTION 1  
INCREASED MAXIMUM ZERO FUEL WEIGHT LIMIT AND  
INSTALLATION OF SAFETY SYSTEMS FOR  
BEECHCRAFT B200GT AND B200CGT AIRPLANES  
IN THE KING AIR 250 CONFIGURATION

AIRPLANE FLIGHT MANUAL SUPPLEMENT

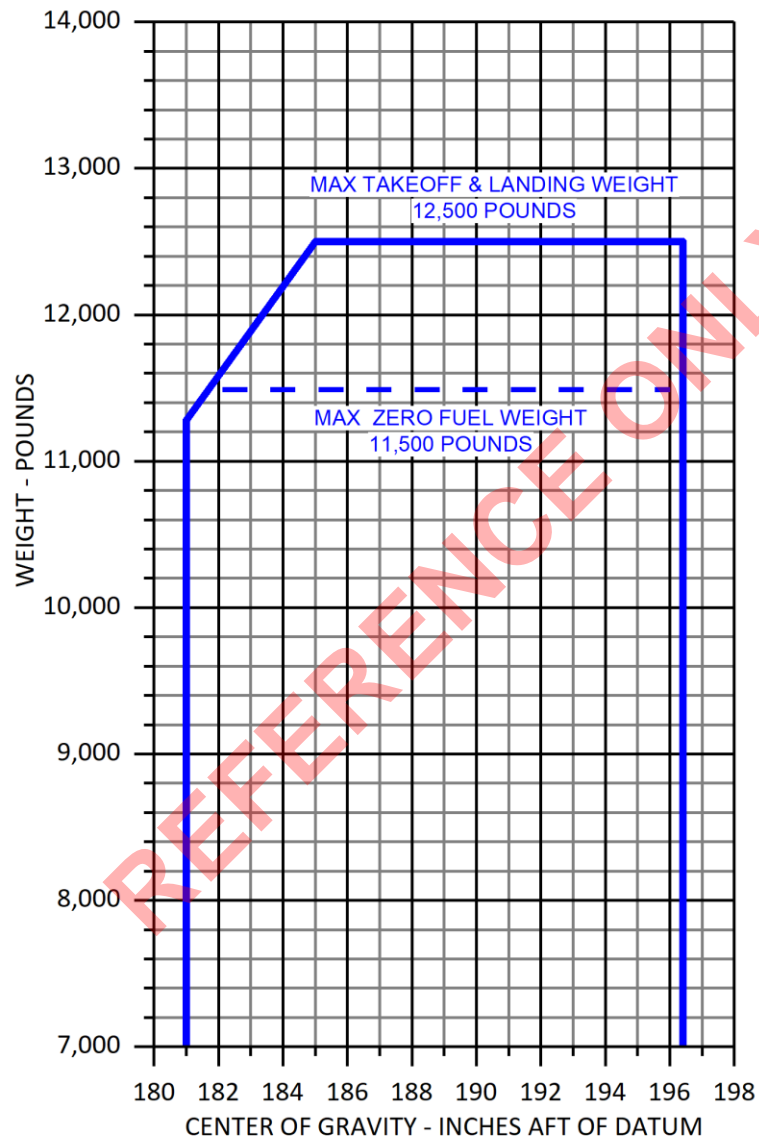
**WEIGHT AND BALANCE DIAGRAM**

Maximum Zero Fuel Weight .....11,500 pounds

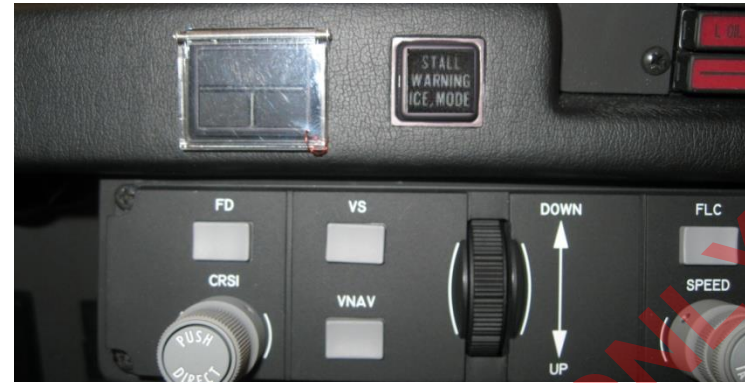
FIGURE 7-2  
STALL WARNING ICE MODE ANNUNCIATOR

Switching to the ice mode occurs automatically when the pilot selects either SINGLE or MANUAL on the Surface Deice switch. The STALL WARNING ICE MODE annunciator, which is located in the glareshield in front of the pilot, will illuminate whenever the ice mode is active (See FIGURE 7-2). The ice mode will stay active until it is manually deactivated by the pilot pressing the illuminated annunciator. This should be done when the airplane is outside of icing conditions and is free of ice. Pressing the annunciator when it is extinguished has no effect. Note the stall warning heat must be operating when flying in icing conditions to keep the lift transducer free of ice.

The King Air 200 series stall warning system does not have the capability to adjust for the effect that icing has on stall speed. Ice accretion causes the wing to stall at a lower angle-of-attack and can result in a 15% to 20% increase in stall speed. The Halo 250/275 conversion adds additional capability so a reliable and accurate stall warning is available in icing conditions. This new stall warning functionality is called the "ice mode".

When testing the stall warning system, the mode in operation when the test is performed is the mode that is tested. A constant tone will be heard if the system is functioning properly. The new system components are located inside the aft end of the console.

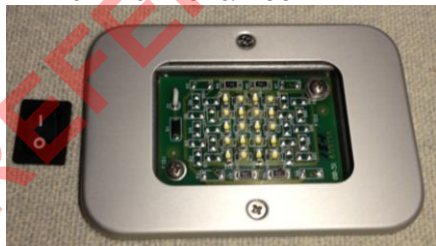
FIGURE 7-3  
EMERGENCY CABIN LIGHTING SYSTEM  
CABIN SWITCH & FLOOD LAMP

Two switches operate the system and provide required functionality. A cabin switch located next to the aft flood lamp connects the battery pack to the system (See FIGURE 7-3). A control switch located in the pilot's sub-panel arms automatic operation or provides manual operation of the flood lamps from the cockpit (See FIGURE 7-4). Power to charge the battery pack is fed from the main electrical bus through a five (5) amp circuit breaker labeled EMERG LIGHT in the copilot circuit breaker panel (See FIGURE 7-5 thru FIGURE 7-8).

The Halo 250/275 conversion adds an emergency cabin lighting system. It provides supplemental lighting in the cabin around the emergency exit door and cabin door. The system has two LED flood lamps located in the cabin ceiling that are powered by a dedicated battery pack, which contains two 12-volt, sealed lead-acid batteries connected in series, installed under the cabin floor.

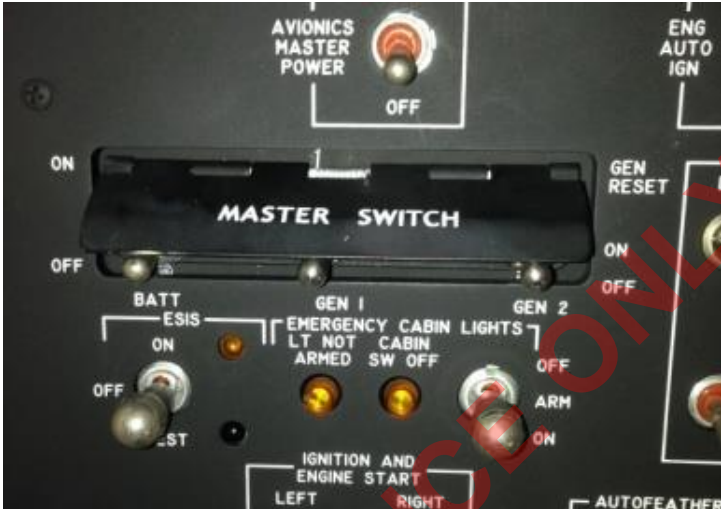
FIGURE 7-4  
EMERGENCY CABIN LIGHTING SYSTEM  
COCKPIT CONTROL SWITCH and WARNING LIGHTS

Two amber indicator lights located adjacent to the control switch (See FIGURE 7-4) warn the pilot when the system switches are not set as required for taxi and takeoff operations. The amber indicator lights will be extinguished when the cockpit control switch is ARMED and the cabin switch is ON. Note these are the required positions for taxi and flight operations.

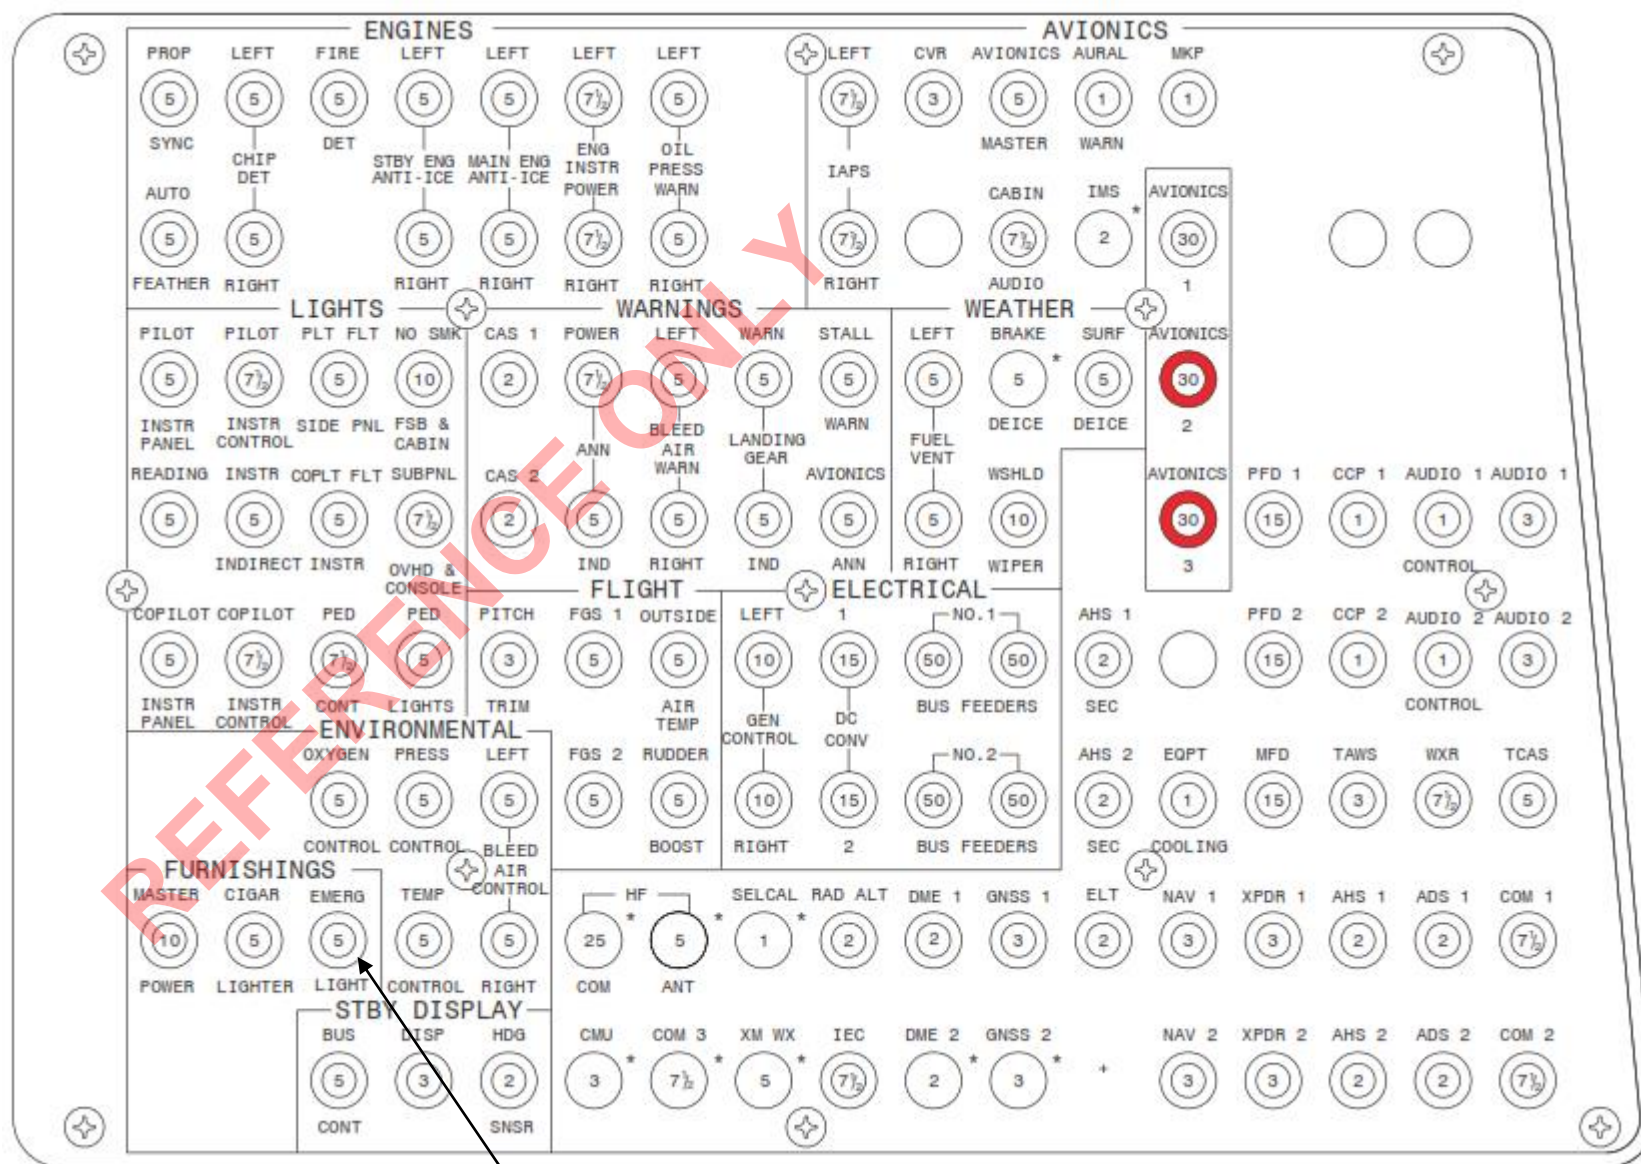
FIGURE 7-7  
RIGHT CIRCUIT BREAKER PANEL (PRO LINE FUSION)

\* OPTIONAL/IF INSTALLED

NOTE: SOLID RED COLOR BAND AROUND CB IS FOR LOAD SHEDDING.
